# Carroll Engineering Roadway Maintenance Evaluation

Dated November 2023

*Review and Comments*

11.27.2023

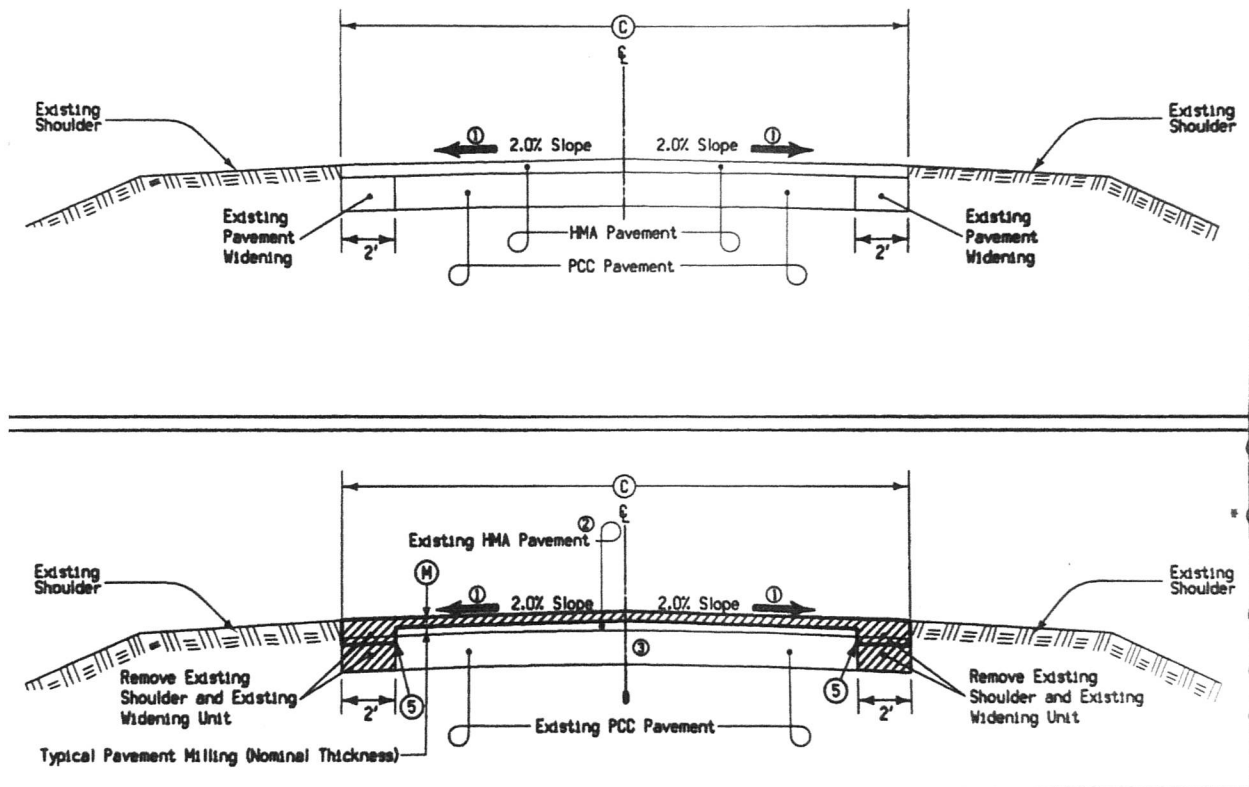
# Example of a typical two lane road asphalt overlay

During the field survey that was conducted by Mr. Snyder, Mr. Pizzola, Ms. Seader, General Asphalt, and me, it was noted by Mr. Snyder that in the areas where center of the road asphalt was ½", the asphalt at the road edge was 3" or more. Indicating that the paver screed was not properly adjusted to the road's pitch or crown as stated in paragraph three.
